**SAS Superstructure**

Daily Diary Report by Bid Item

Contract No.: 04-0120F4

**04-0120F4
04-SF-80-13.2/13.9
Self-Anchored
Suspension Bridge****Weather**

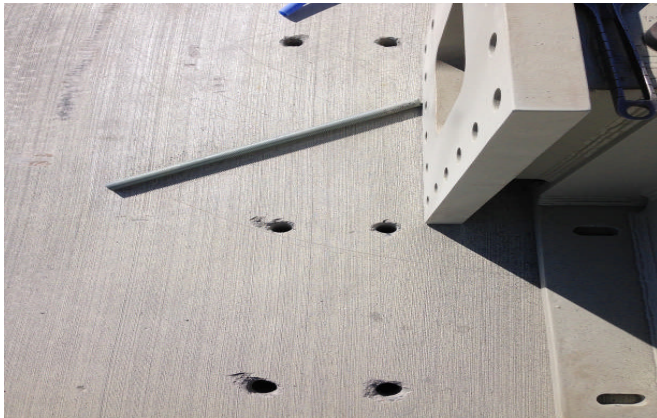
1" Anchor rod adjacent to Concrete Footing

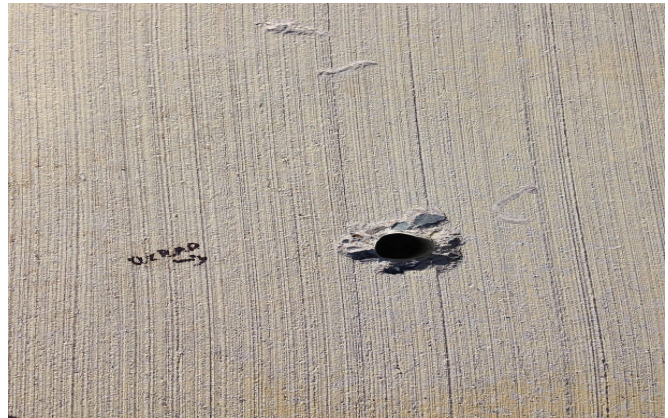
A second iron worker came to assist with the drilling operation on test rig # 5 concrete footing. One of the workers indicated that the drill bit is hitting some rebar during the drilling and that ABF is expecting to buy a drill bit adaptor to fit a drill bit that drills through rebar. He indicated that the adaptor may arrive tomorrow to finish the 9" deep rod holes and if the adaptor arrives workers should be able to continue drilling. Note that during some of the drilling, the larger drill bit hit rebar in about 3" deep of drilling in four (4) locations on the dead end side for test rigs # 5 on the concrete footing.

Closer view of anchor rod hole where drill bit hit rebar

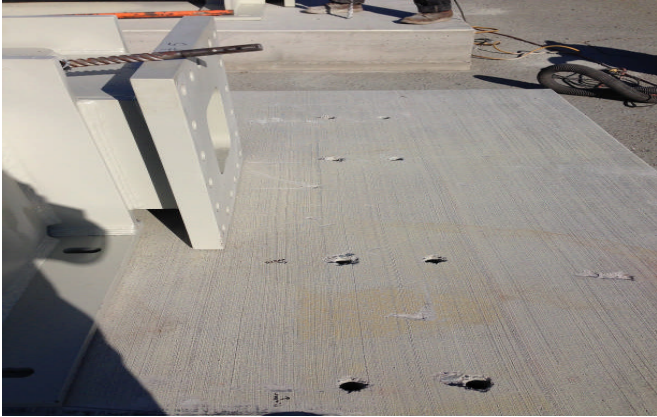
A foreman for the iron workers came by about 1635 and left about 1648 to see the drilling. Workers used the extendable forklift to move the test rig # 5 away from the smaller holes that were previously drilled in order to drill larger holes. I observed an iron worker use the forklift to wheel out another generator outside the test rig site. Workers cleaned up and left the job site by about 1715. Note that there were several bolt holes where the drill bit hit the rebar in test rigs 5 and 6. I did not see any short anchor rod holes on test rig 7 concrete footing that hit rebar.

Several locations on the left bolt hole layout that drill bit hit rebar at about 3" deep and not reaching required depth of 8"

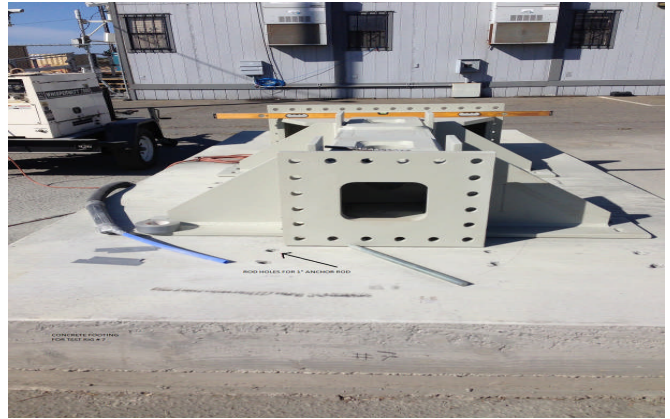
Test Rig #7 - Anchor Rod Holes for 1" Rods

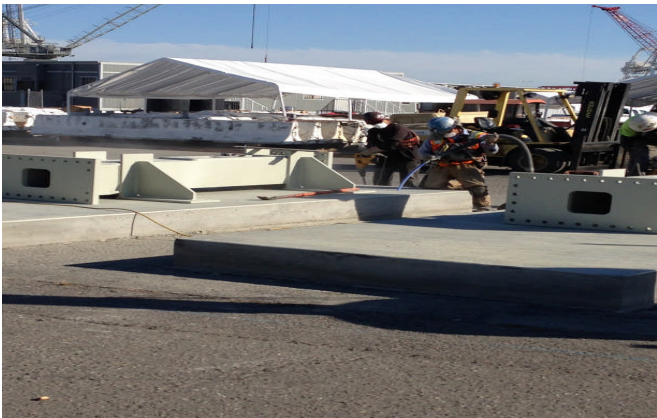
About 1540, the laborer began emptying out the vacuum and then continued assisting the iron workers in cleaning out rod holes after holes were drilled. One of the iron workers left the test rig site about 1627 to grab a fitting for the vacuum. The laborer also left the job site to get cleaning supplies.

Laborer Cleaning Anchor Rod hole after drilling

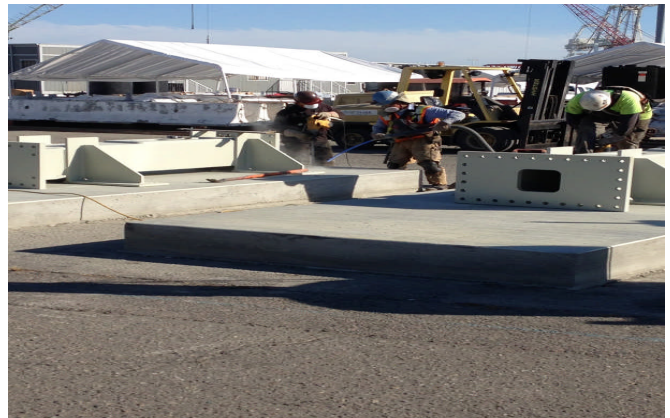
A laborer was vacuuming / cleaning out holes that were previously drilled into the test rig concrete footings. An iron worker first drilled small diameter holes and then in the same hole drilled a larger diameter hole that were about 9" deep to fit a 1" diameter anchor rods. After the iron worker reached the required depth, the laborer would vacuum out rod holes and provided tape to prevent debris to accumulating in holes. The iron worker started drilling on test rig concrete footing # 7 and then moved to #6.

Test Rig 5 & 6 - Iron Workers Drilling Anchor Rod Holes
